NASA CR-72485
PWA FR-3040

FINAL REPORT

FLOX/METHANE

PUMP-FED ENGINE STUDY

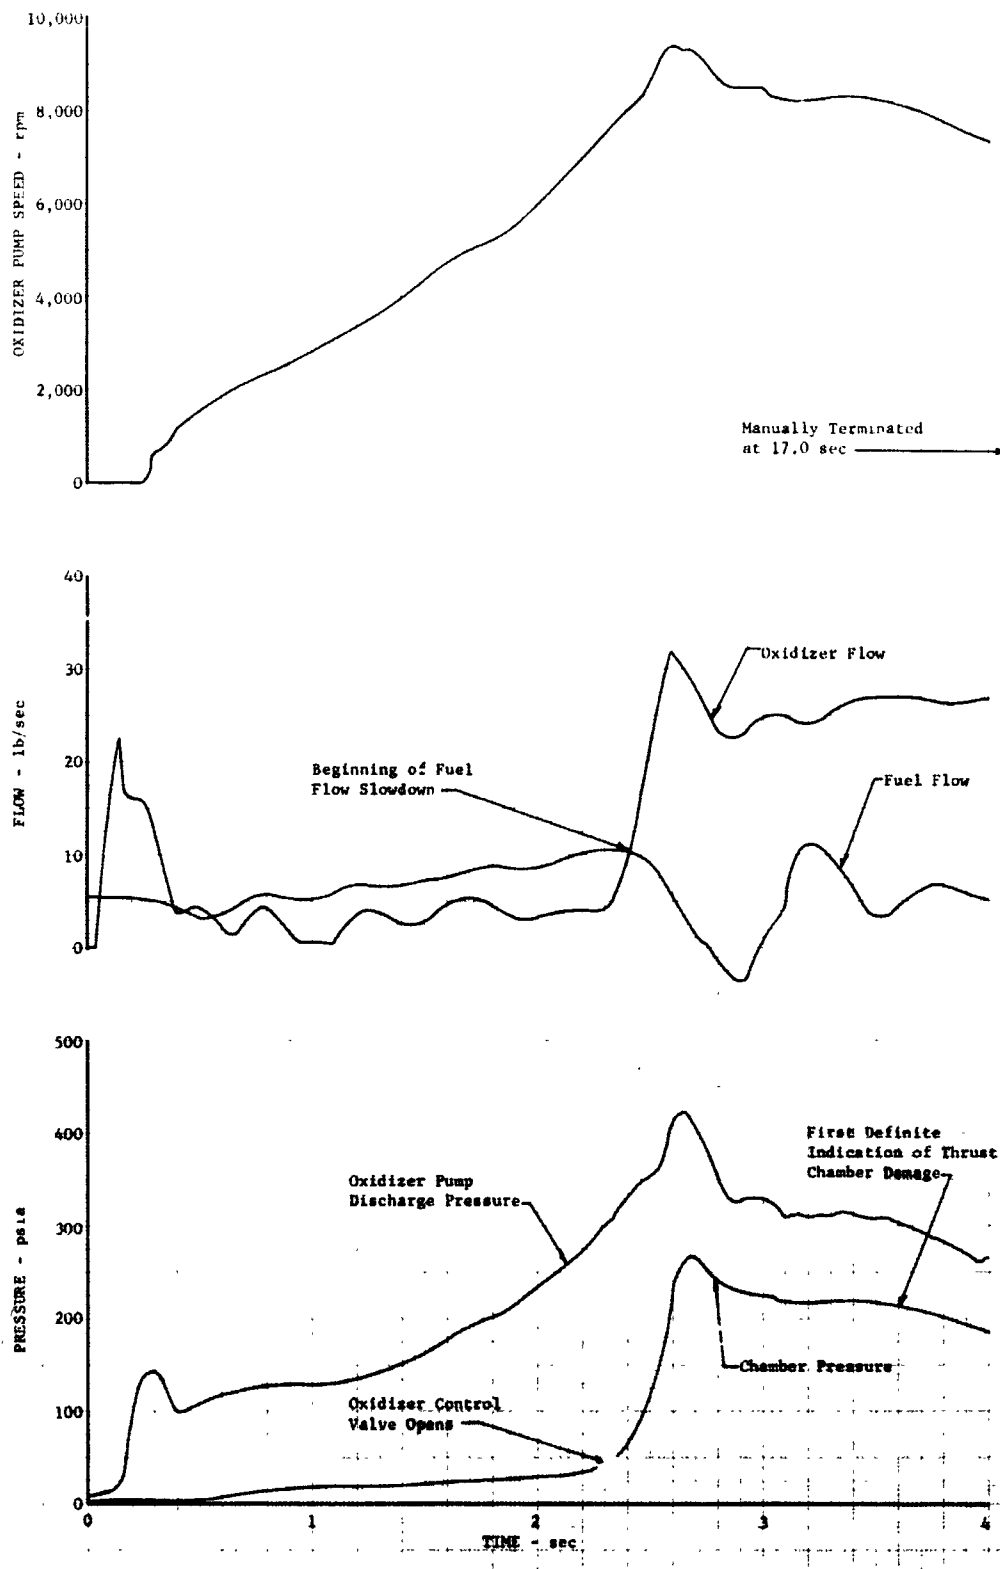
Figure 87. Starting Transient for Engine Test No. E-3

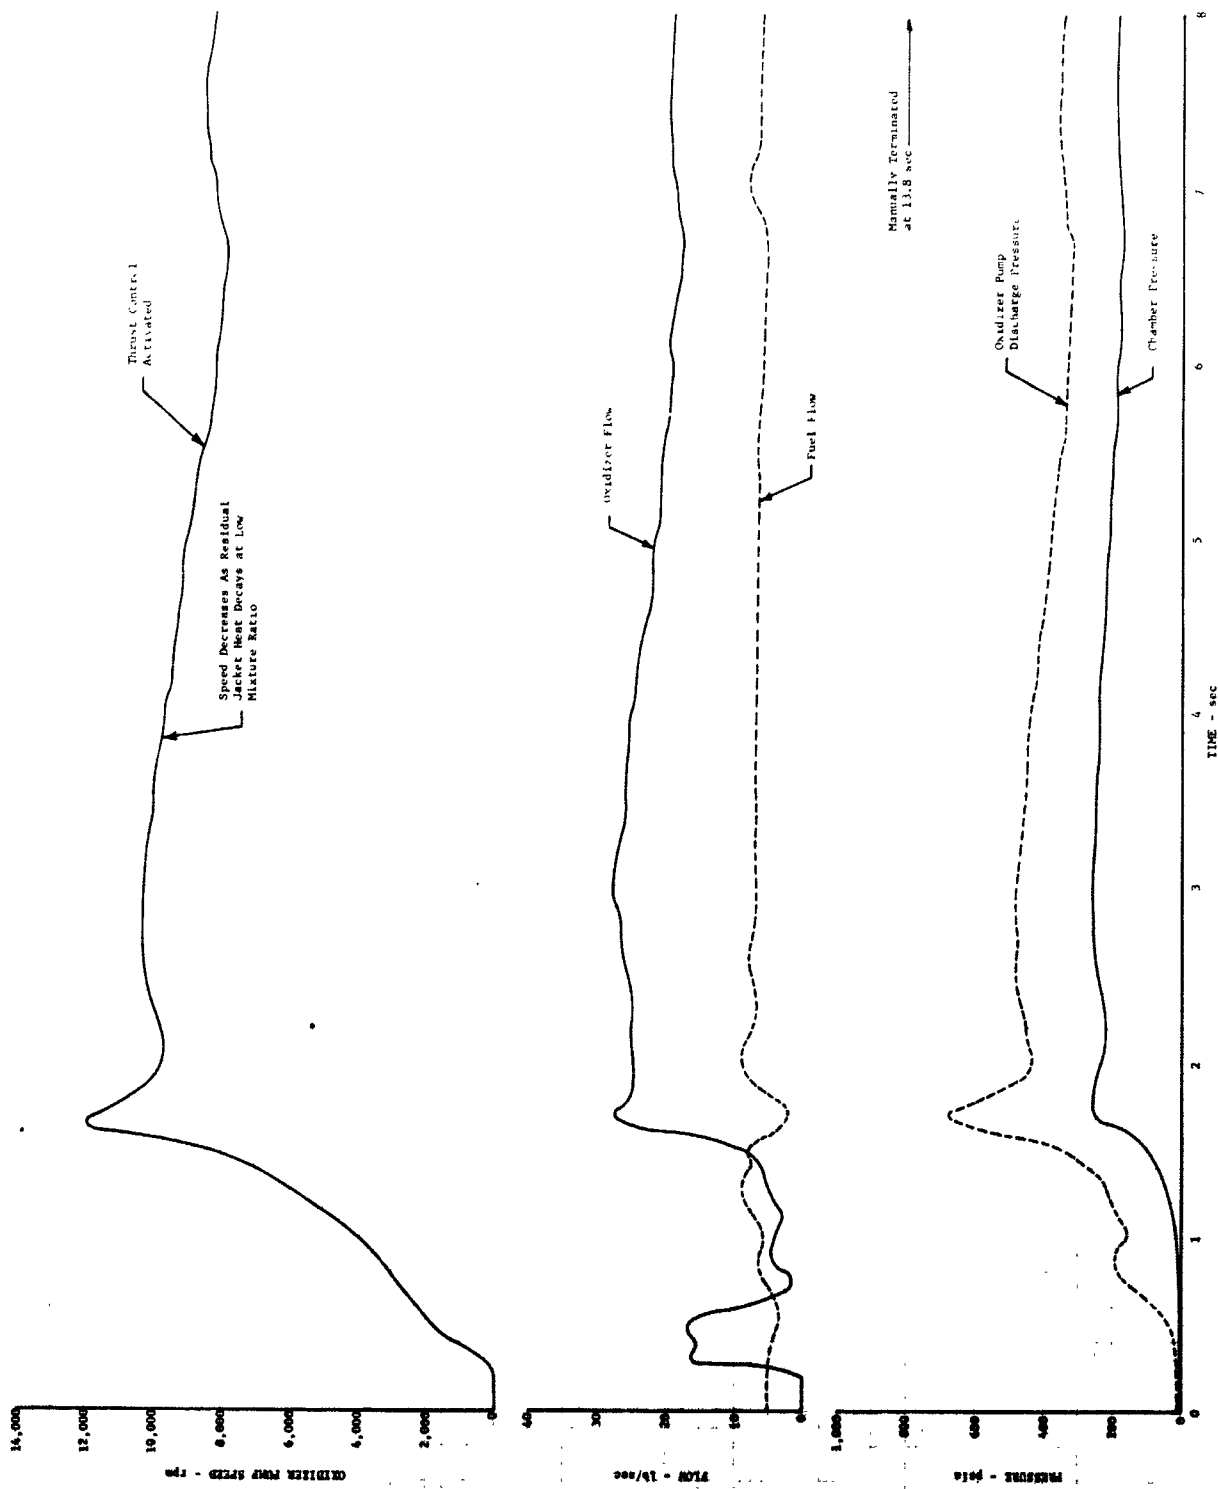
Figure 88. Starting Transient for Engine Test No. E4

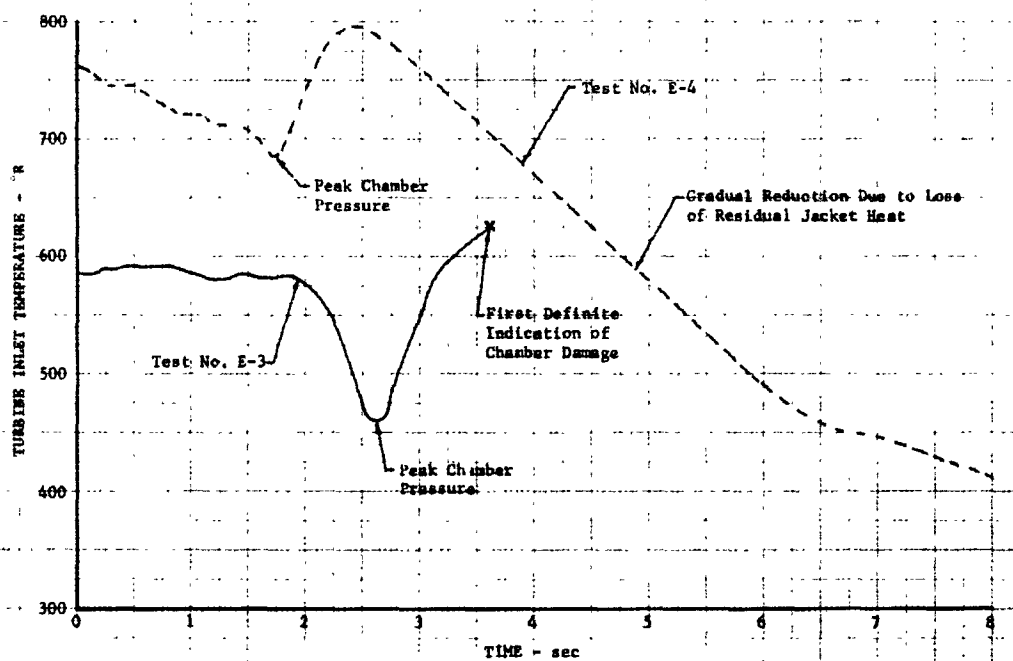
Figure 89. Effect of Engine Modifications on Starting Turbine Inlet Temperature

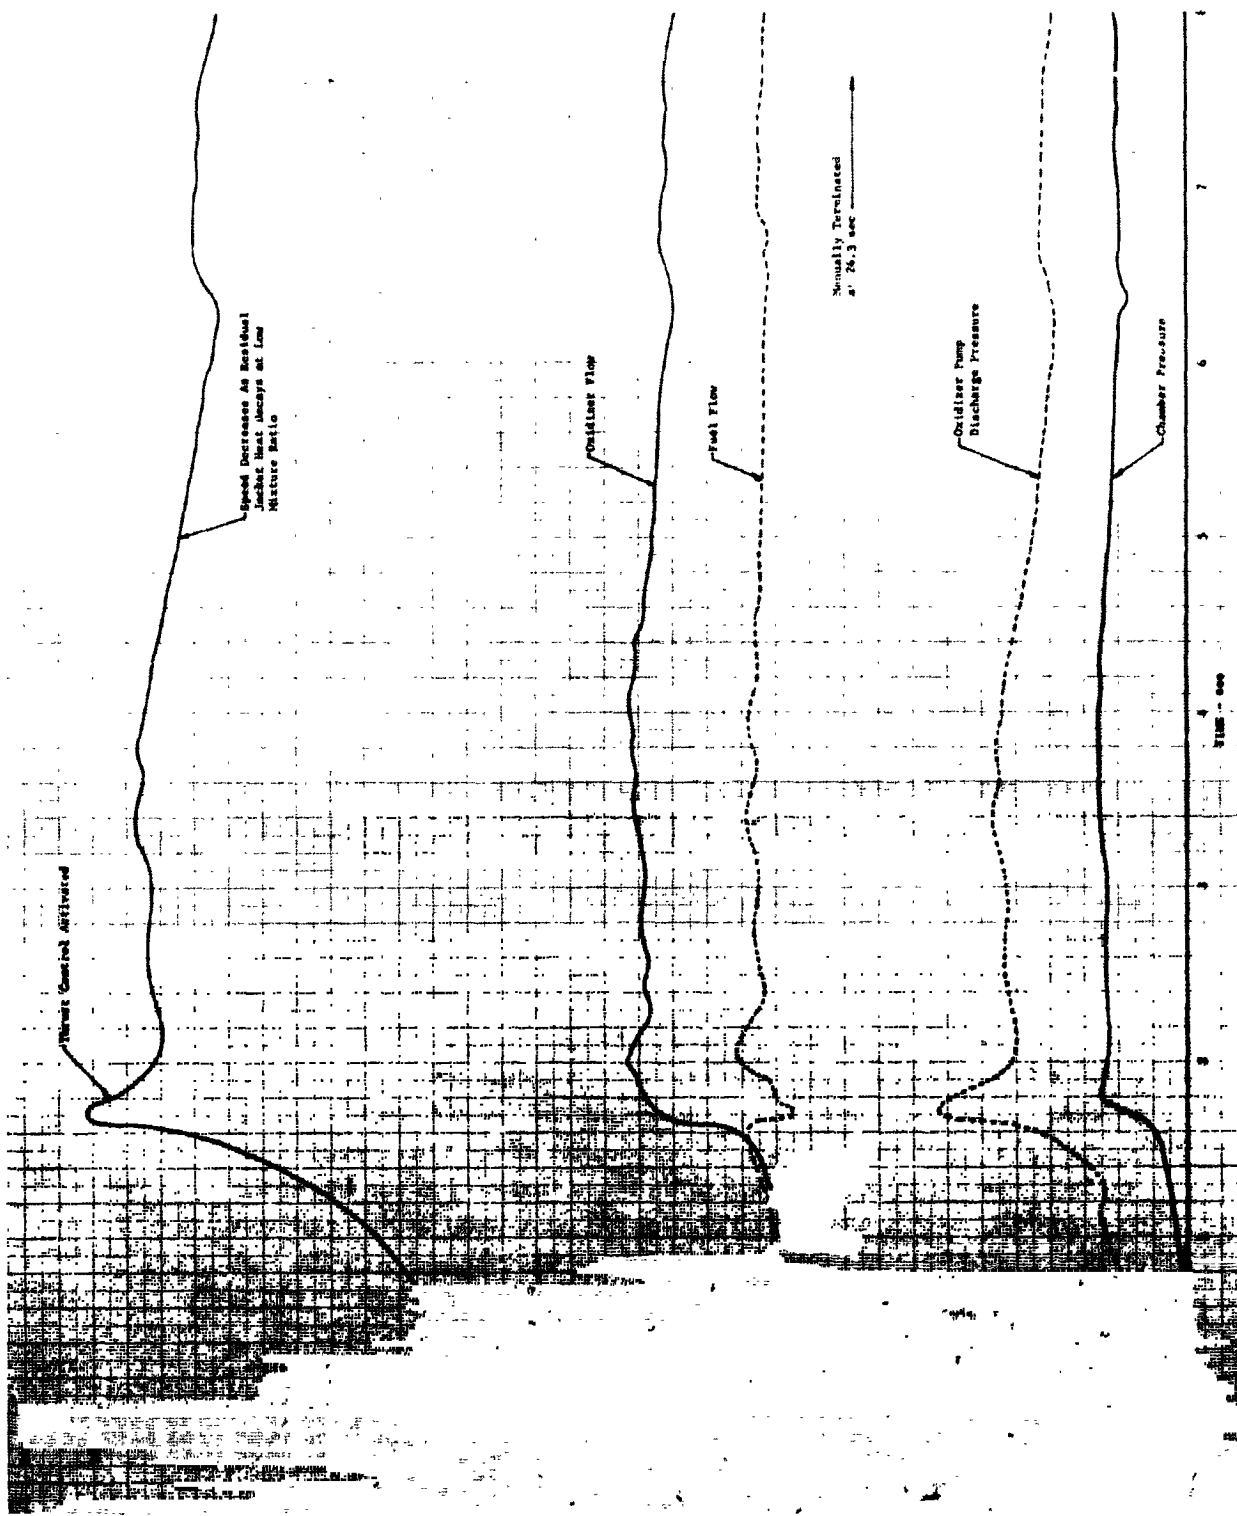
Figure 50. Starting Transient for Engine Test No. E-5

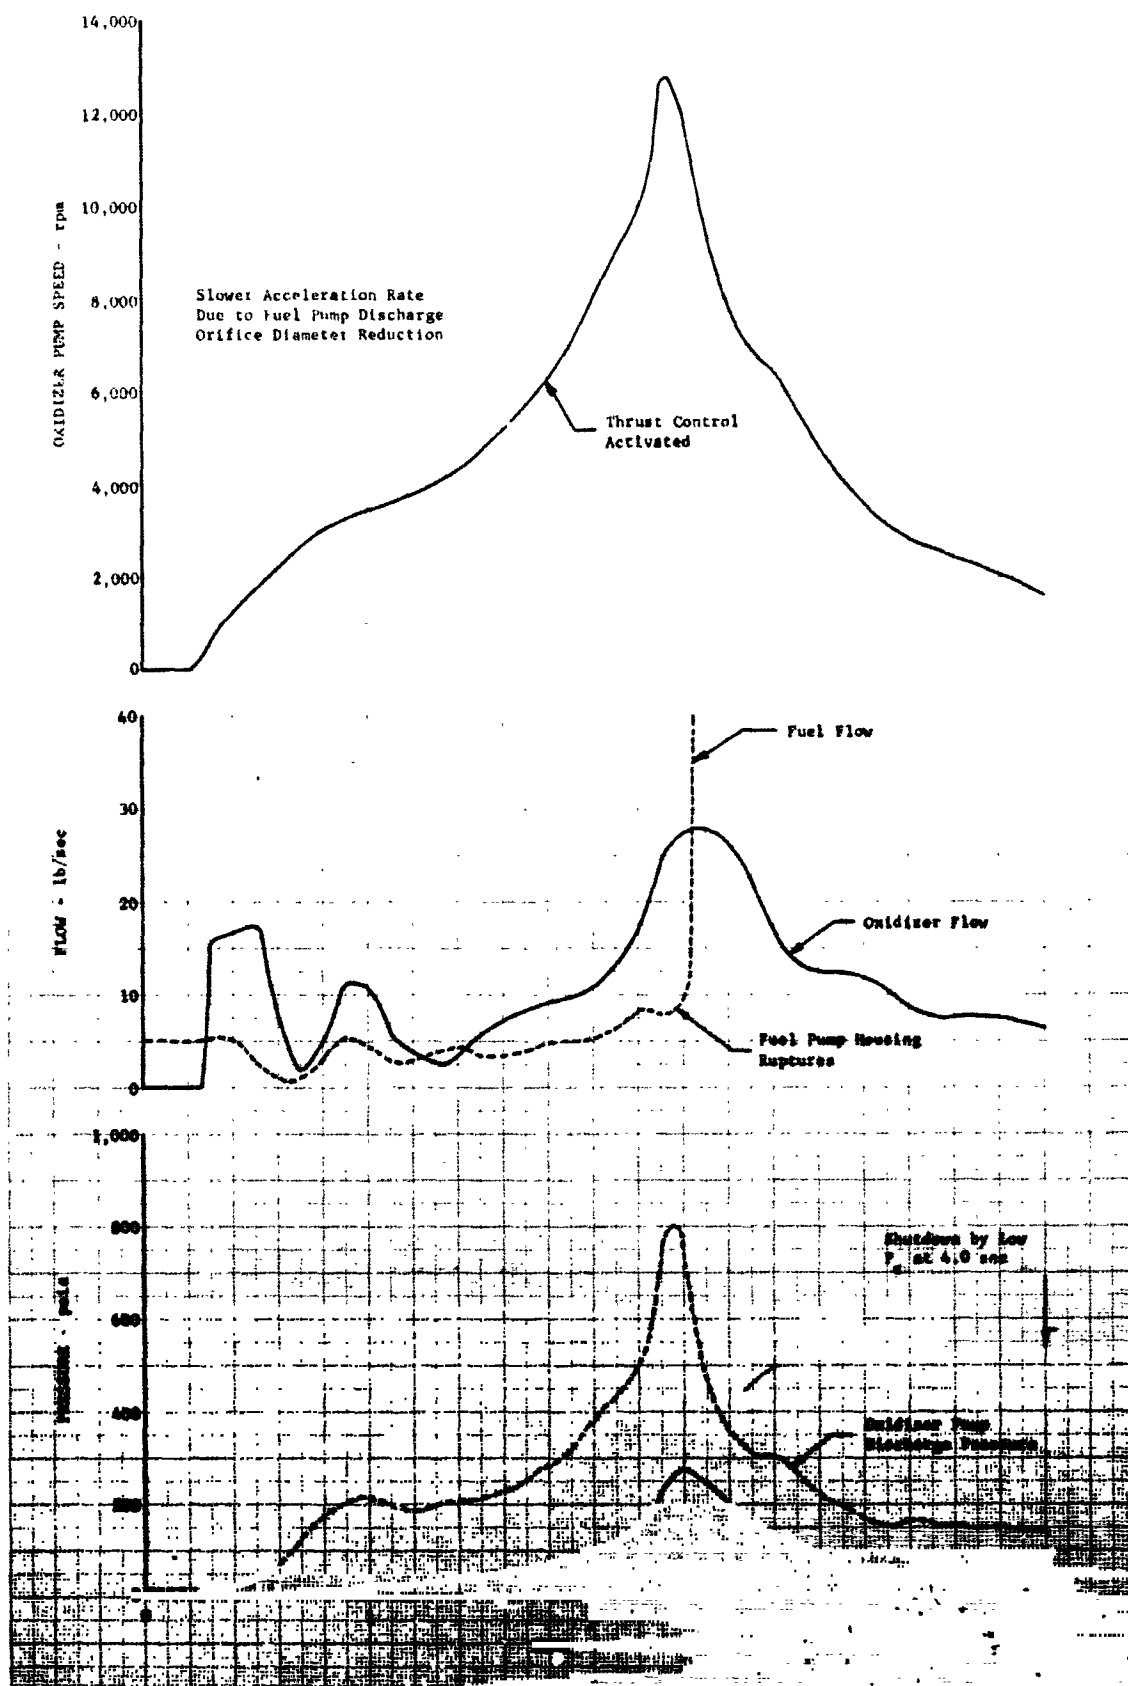
Figure 91. Starting Transient for Engine Test No. E-6

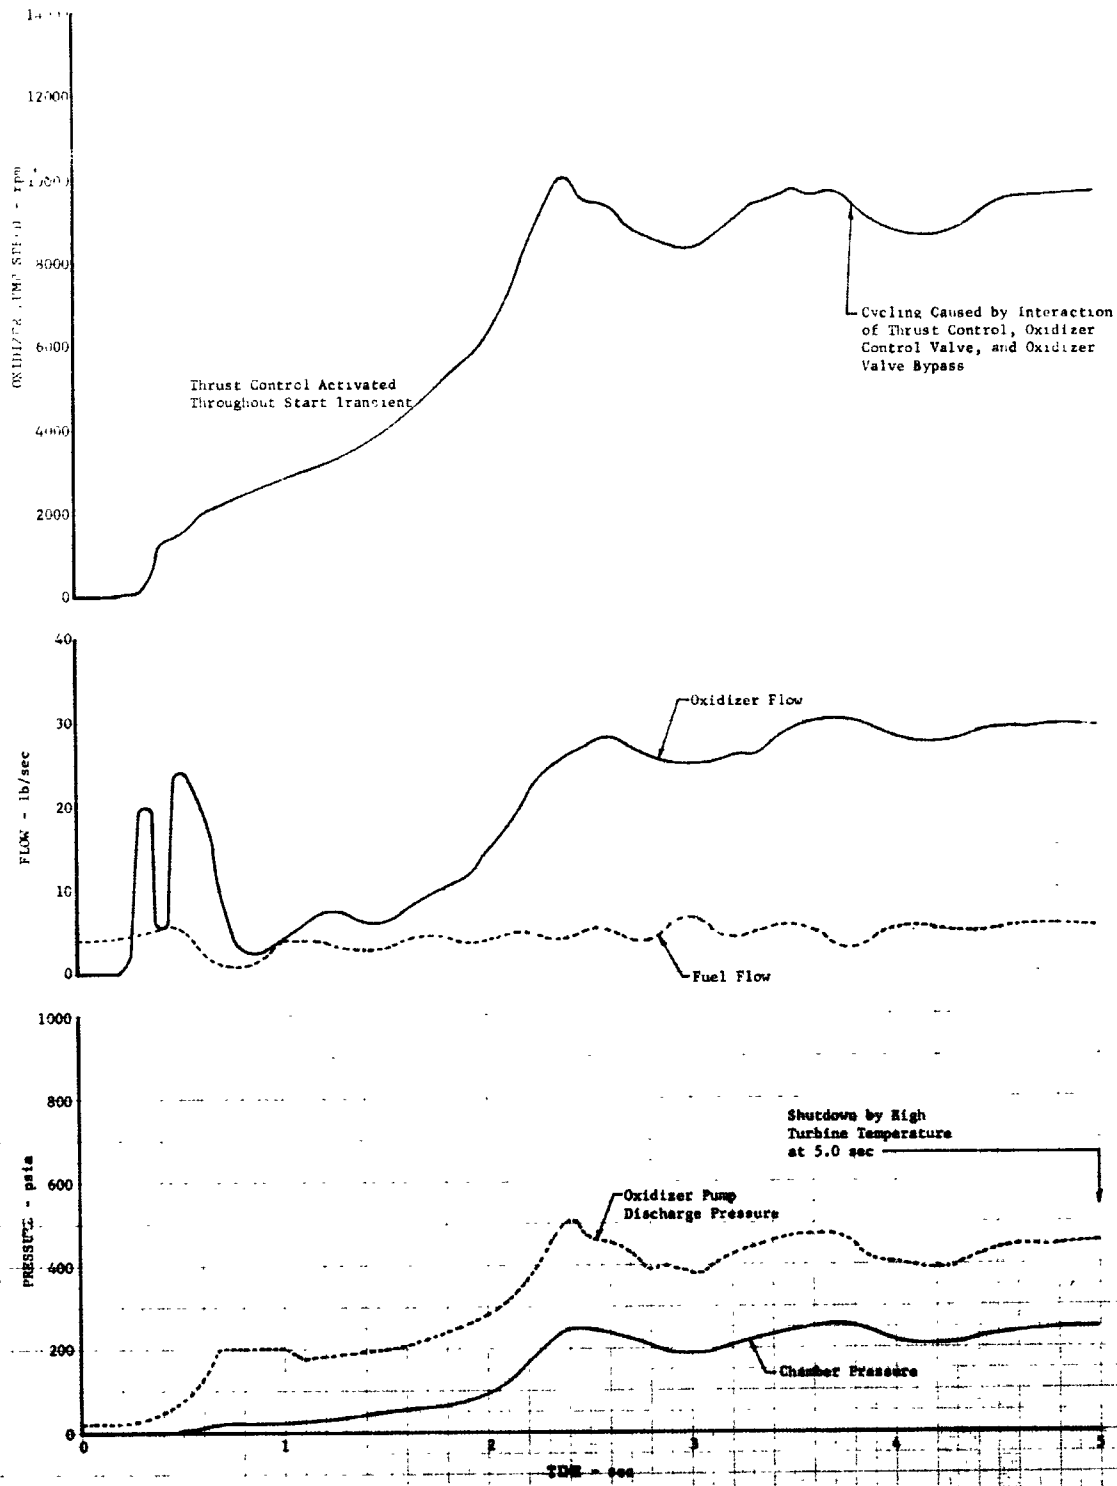
Figure 93. Starting Transient for Engine Test No. E-8

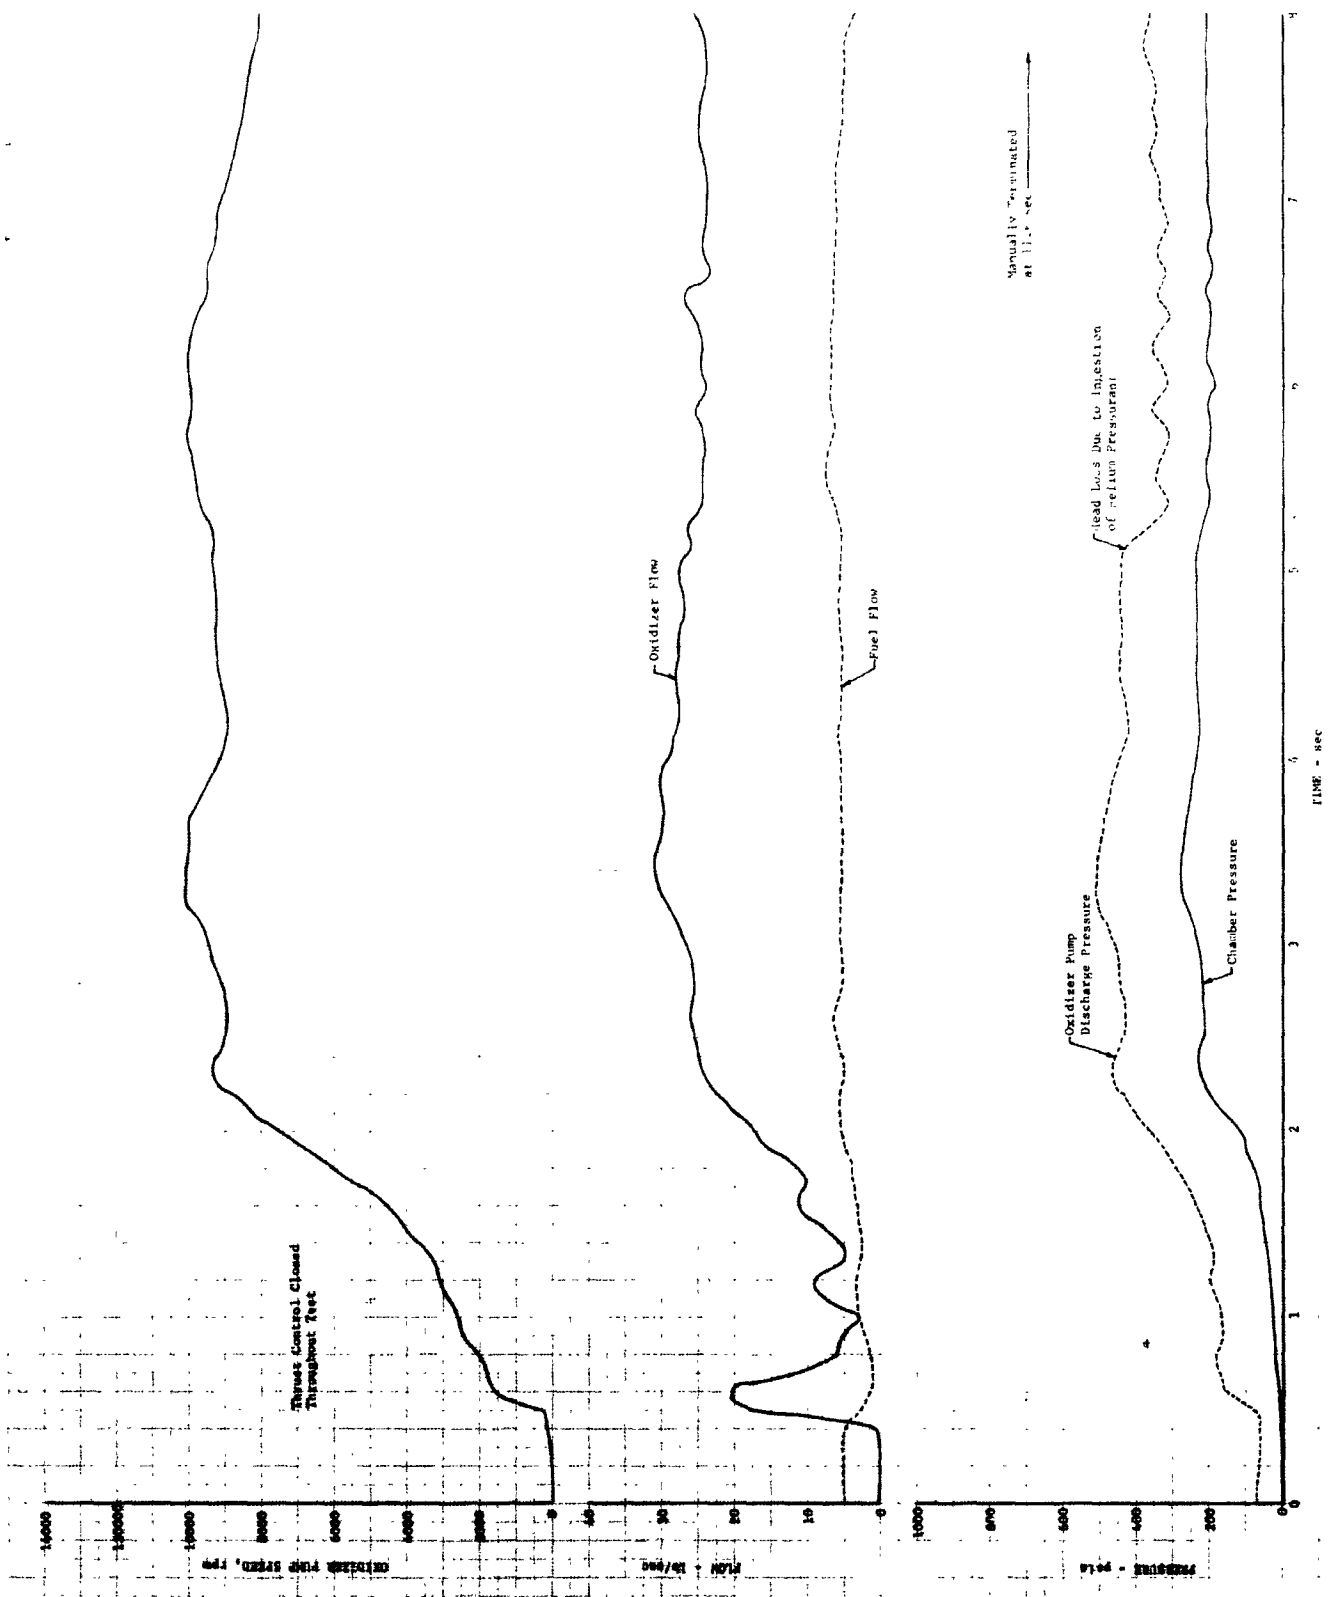
Figure 94. Starting Transient for Engine Test No. E-9
